FACILITY COMPLIANCE INSPECTION REPORT

City of Durham Closed MSW Landfill
2115 East Club Boulevard
Durham, NC 27704

Post Closure Site Visit

Digital pictures taken March 8, 2013
by John Patrone, DWM-SWS

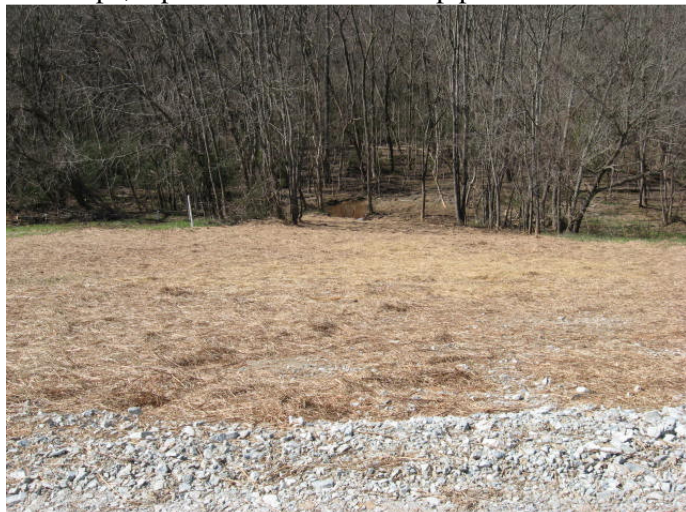
8. The facility is corresponding with SWS - Hydrogeology to ensure appropriate evaluation of the release is conducted.
9. The landfill cap, at the repaired area, is covered with straw.

10. There was no indication of erosion or runoff.

Side slope, repaired area – new drainpipe installed

4. The leachate release was contained the same day, February 22, 2013.
5. On March 5, 2013, Mr. Lobdell informed SWS that the leachate outbreak has been repaired, the stormwater drainpipe has been replaced, and the landfill cap/area repaired.
